## Firewall & Engine Cradle

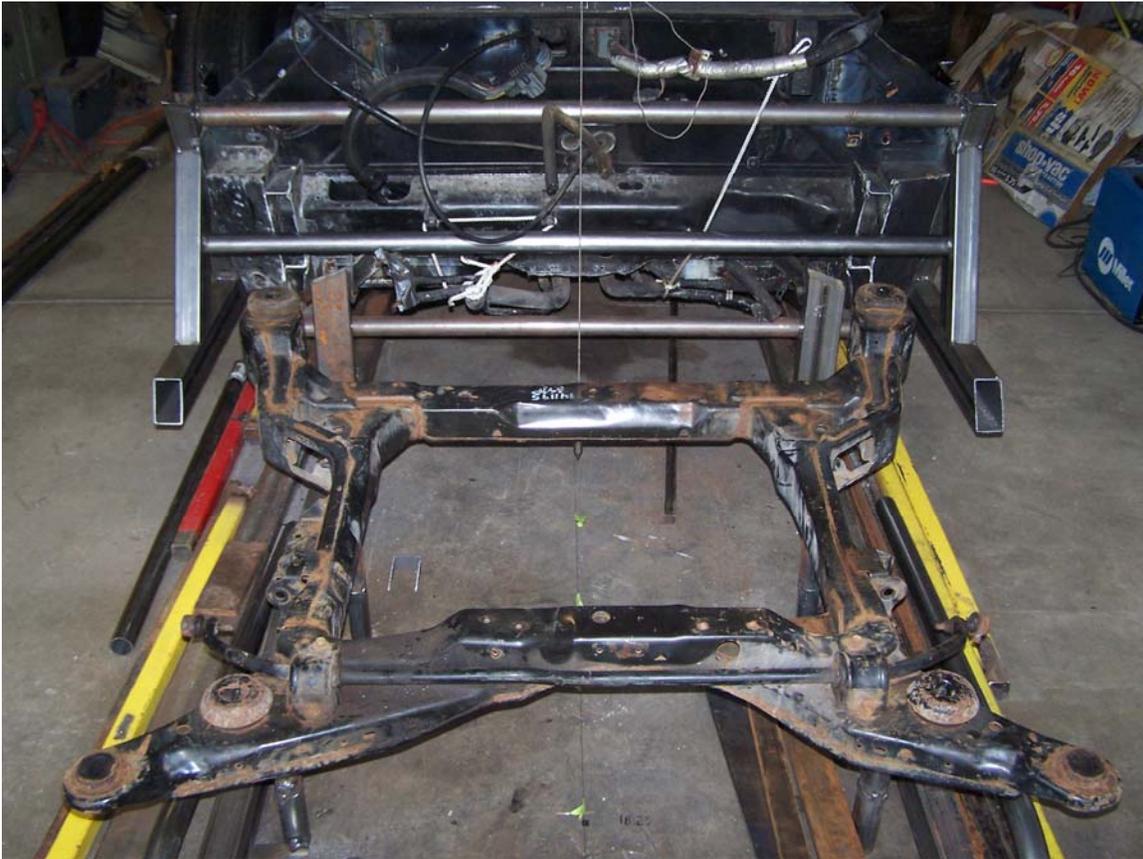
This picture shows that the two firewall cross tubing pieces have been installed, leveled, and welded in place.

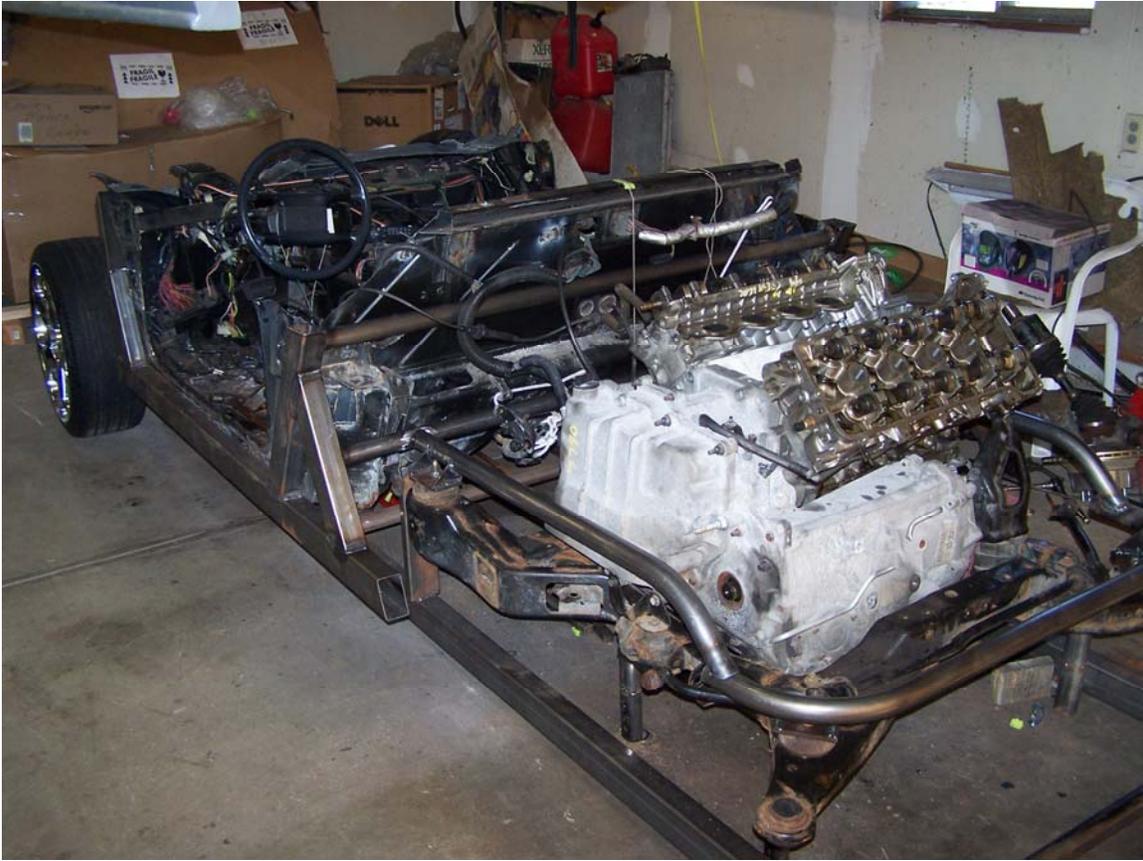
The tubing for the lower hoop has been bent and installed. The four engine cradle attachment brackets are made and welded to the lower tubing hoop. The Cadillac bare block and transmission have been installed to solve clearance problems that may or may not occur. Now I can start on modifying the Cadillac struts to accept coil overs. All measurements at this point are very critical. Measure, measure, measure.
